## INVENTORY FORM FOR STATE HISTORIC SITES SURVEY

Red Lion Miller's Residence

Ben Clark House

QA-294

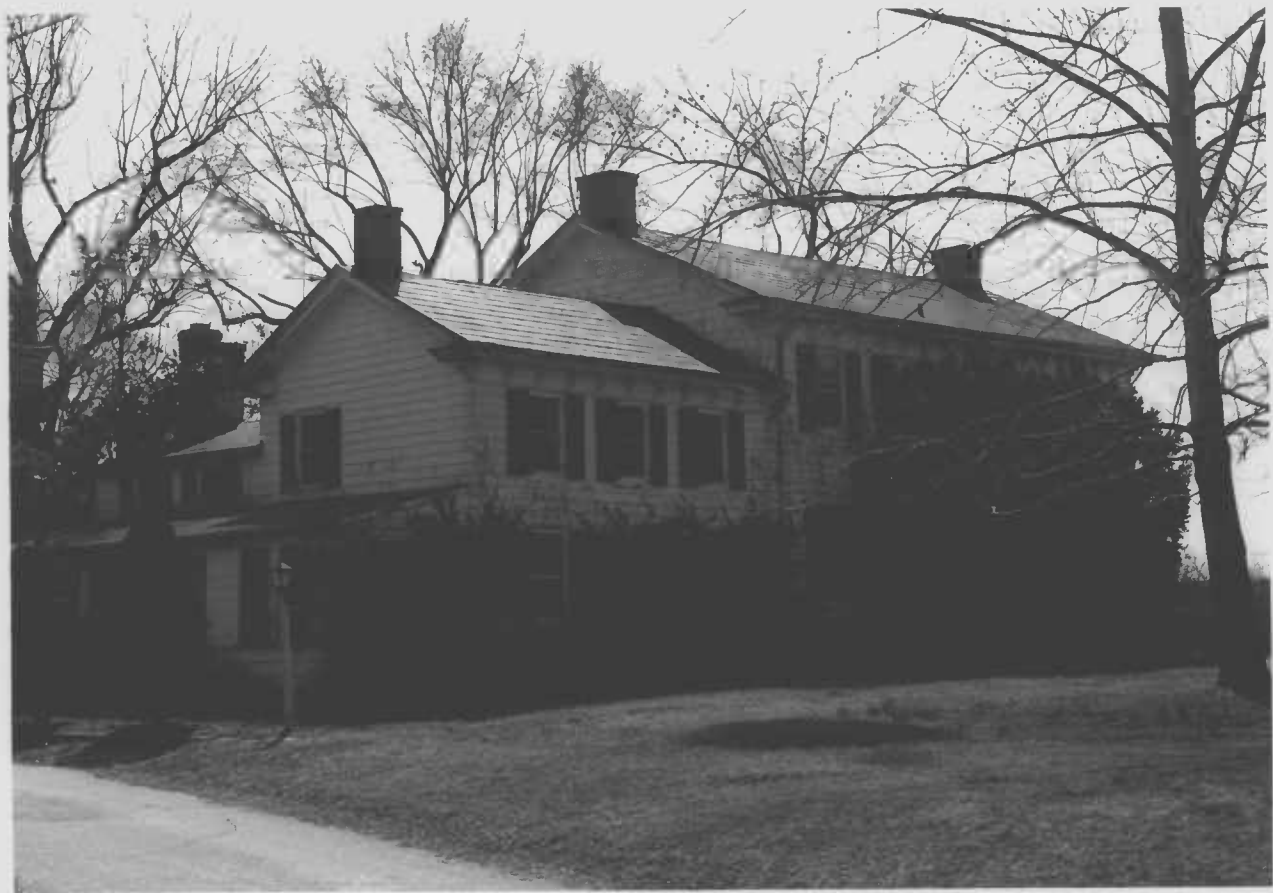
QA-294     Red Lion Mill Residence  
              Crumpton vicinity  
              Orlando Ridout V 1981  
              Front facade from Northeast

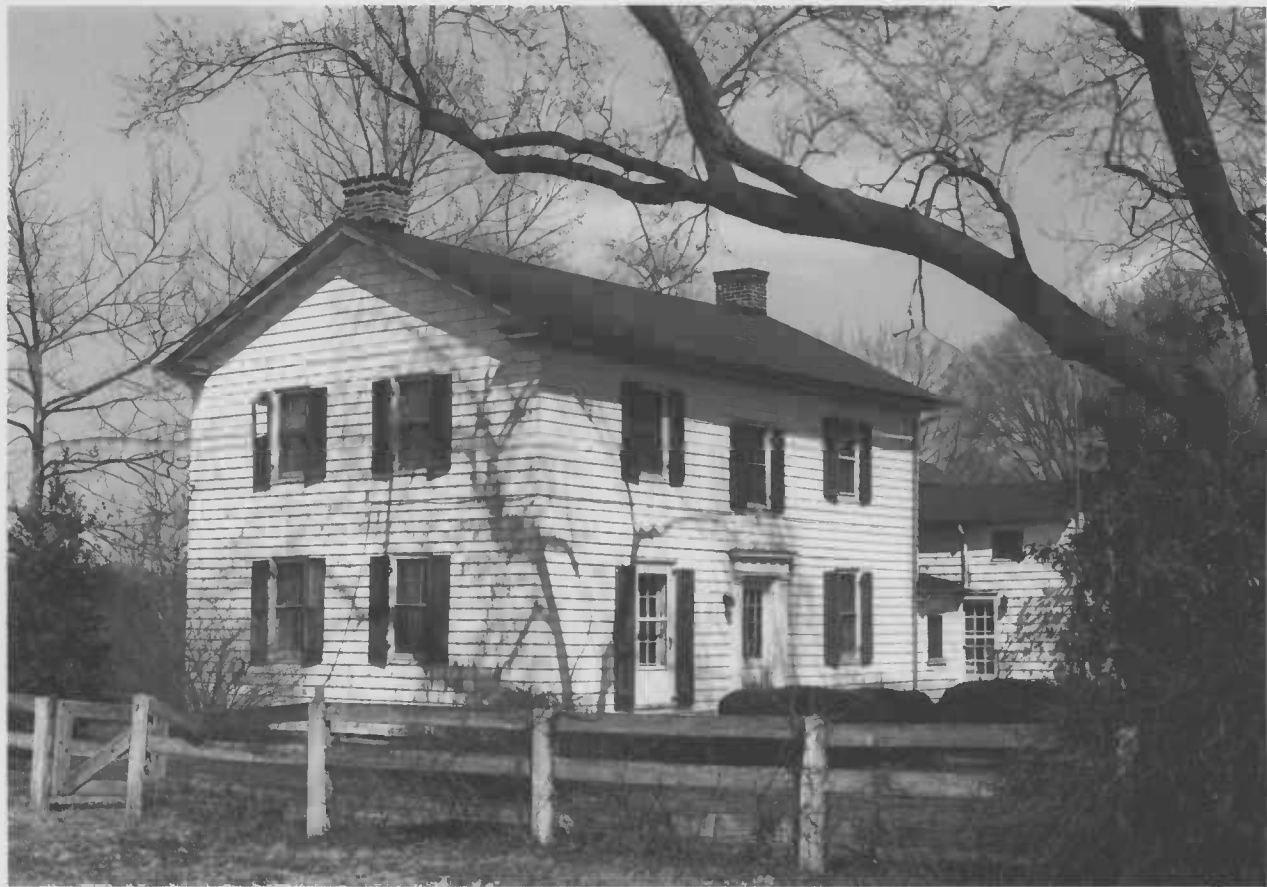
QA-294    Red Lion Mill Residence  
          Crumpton vicinity  
          Orlando Ridout V 1981  
          Rear facade from Southwest
